**City of Stratford**  
**Building and Planning Department**  
P.O. Box 818  
Stratford, ON N5A 6W1

**RE: Cooper Site Building**  
**350 Downie Street, Stratford, ON**  
**Roofing Components - Visual Review**

**RJC No.: TOR.103282.0008**

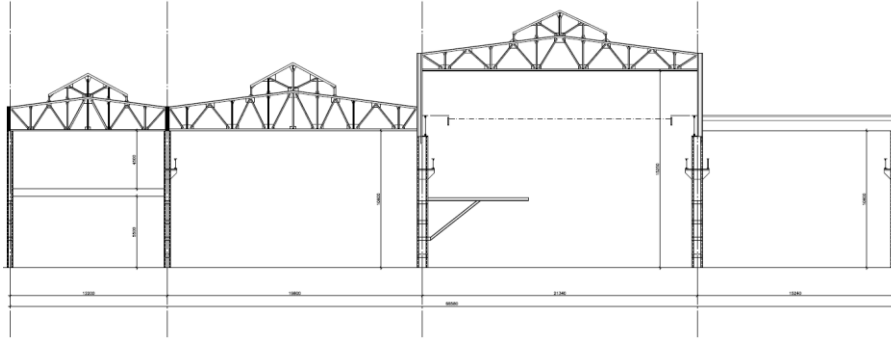
**FIGURE #1: TYPICAL BUILDING SECTION**

The remaining building is generally arranged with four (4) bays, all of which are open from the ground to the roof structure with the exception of the north-most bay, which includes a mezzanine level (*refer to Figure #1 below*). From north to south, the north-most bay (herein referred to as the "mezzanine bay") is approximately 615-ft long by 40-ft wide and 50-ft high to its peak. The next bay south (herein referred to as the "low bay") is approximately 770-ft long by 65-ft wide at a similar height of 50-ft to its peak. The 3rd bay south (herein referred to as the "high bay") is approximately 780-ft long by 70-ft wide and 67-ft high to its peak. Finally, the south-most bay (herein referred to as the "addition bay") is approximately 580-ft long by 50-ft wide and 38-ft high to the roof surface.

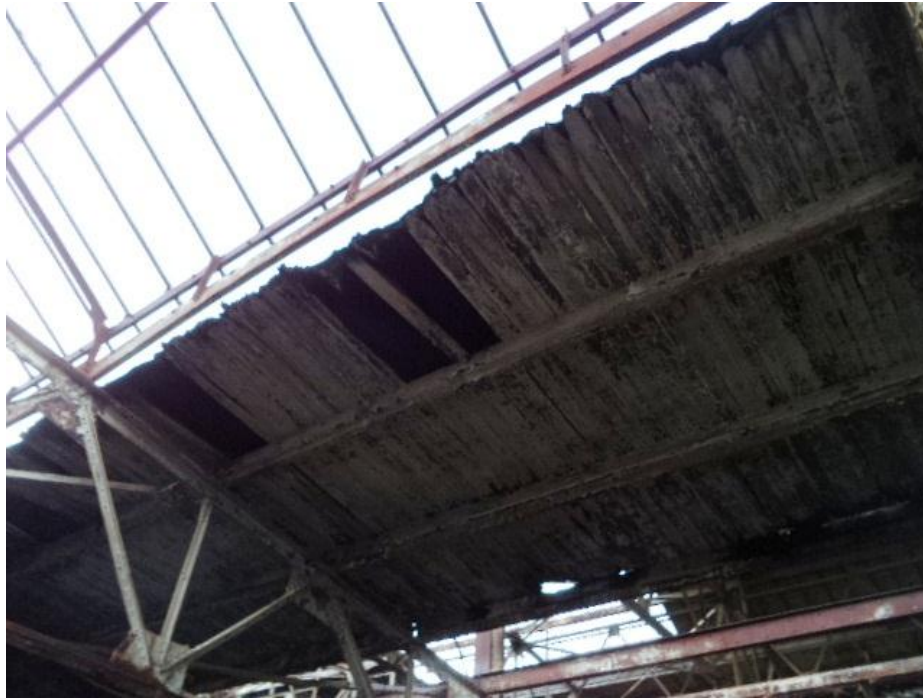
Photo #3: Typical Roof Deterioration

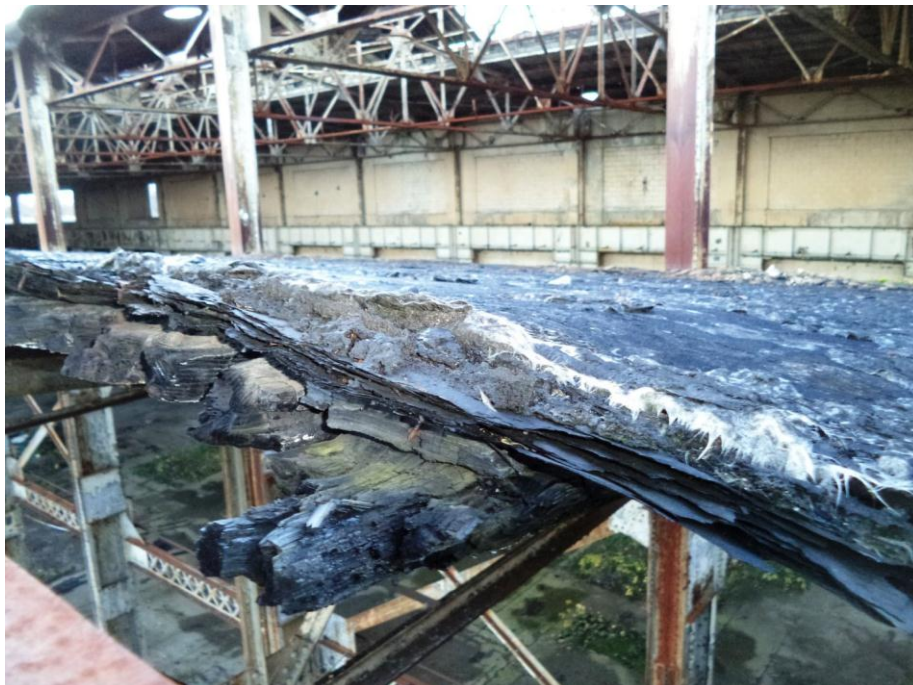
Photo #4: Typical Roof Deterioration

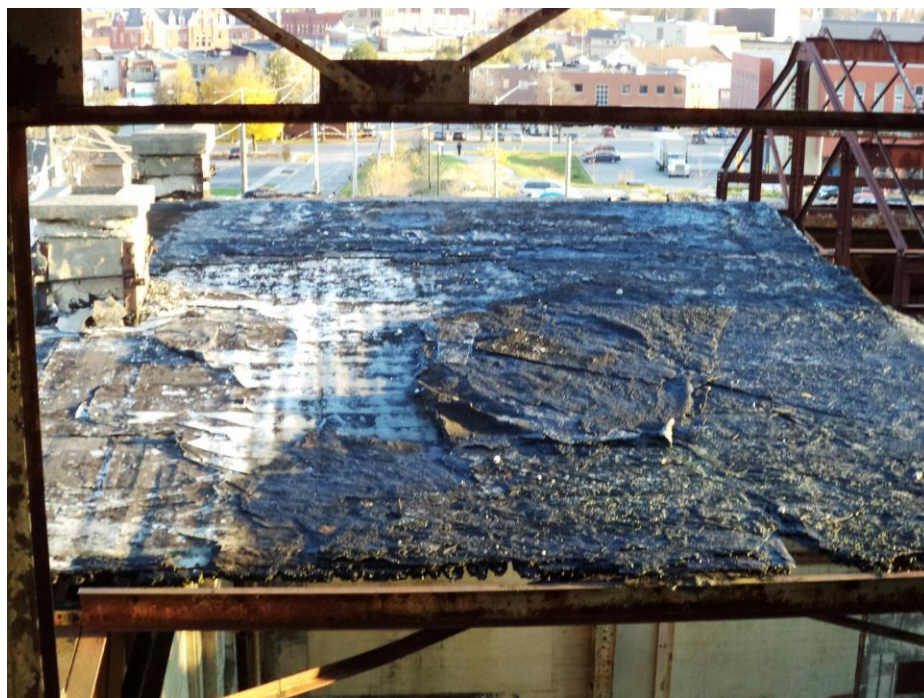
Photo #6: Typical Roof Deterioration

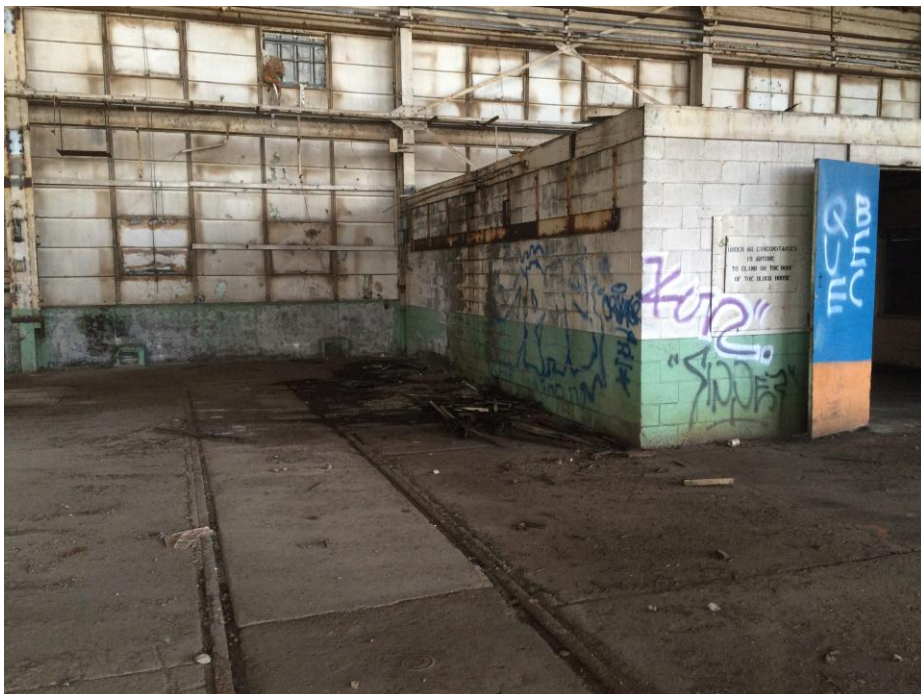
Since the condition and stability of the roof deck material was questionable, only a cursory review of the roof surfaces could be performed through the skylights and the burnout sections of the roof from a boom lift. From the cursory review of the roof surface performed, it was obvious that the roofing materials had well exceeded their useful service life, were in a state of complete disrepair, and were no longer functioning as intended. Fallen roofing debris was noted throughout the interior of the building and around the perimeter of the exterior of the building (*Refer to Photograph #8 in Appendix A*).

Photo #8: Roofing Debris Scattered Throughout the Site
