Read Jones Christoffersen
Consulting Engineers

Suite 500
144 Front Street West
Toronto, ON M5J 2L7
Canada

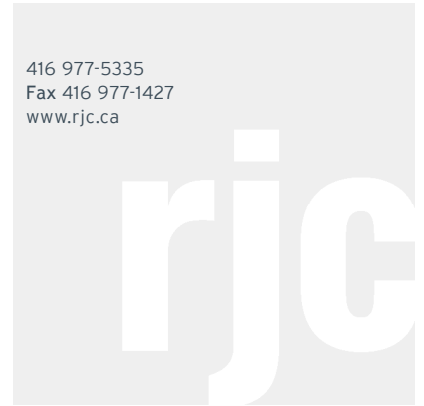
BUILDING CONDITION ASSESSMENT REPORT
CITY OF STRATFORD COOPER SITE
350 DOWNIE STREET, STRATFORD, ONTARIO

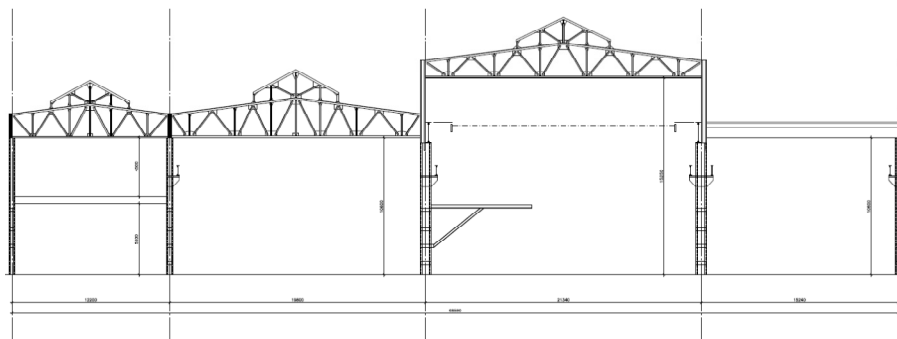
FIGURE #1: TYPICAL BUILDING SECTION

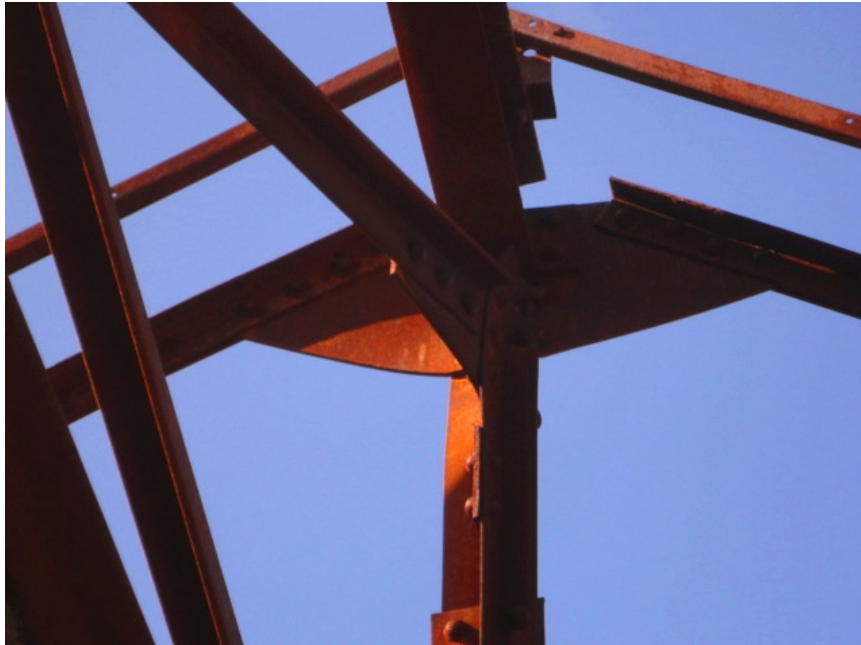
Photo #14: Typical steel corrosion in apex of roof in fire damaged region

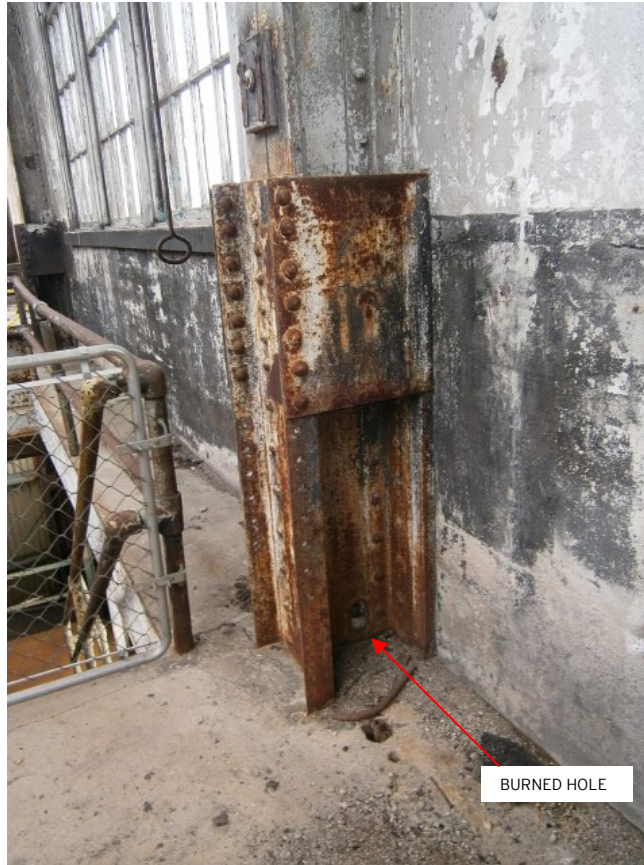
Photo #24: Burned hole through column web

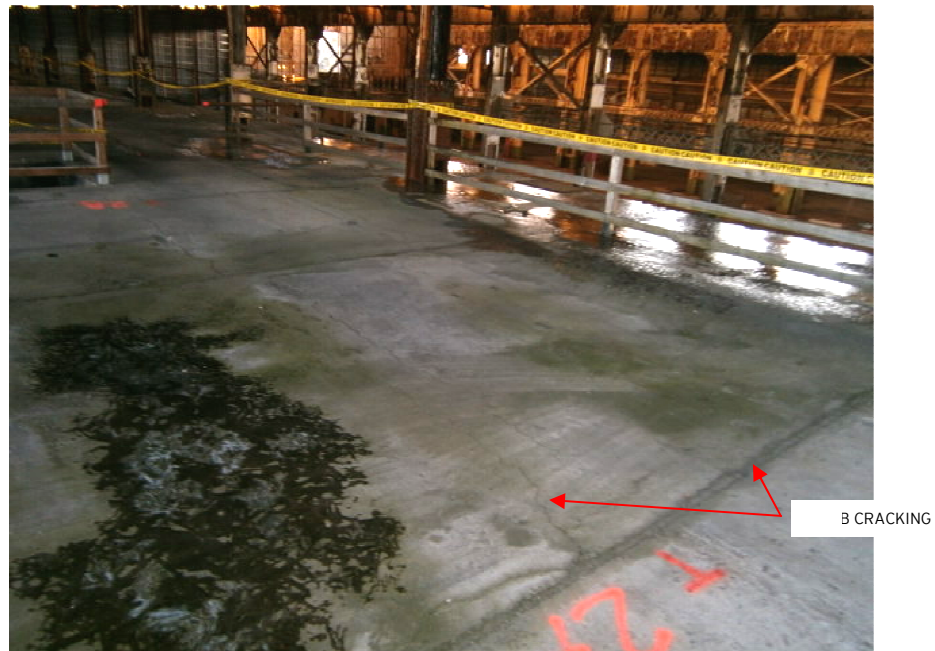
Photo #26: Typical mezzanine slab cracking

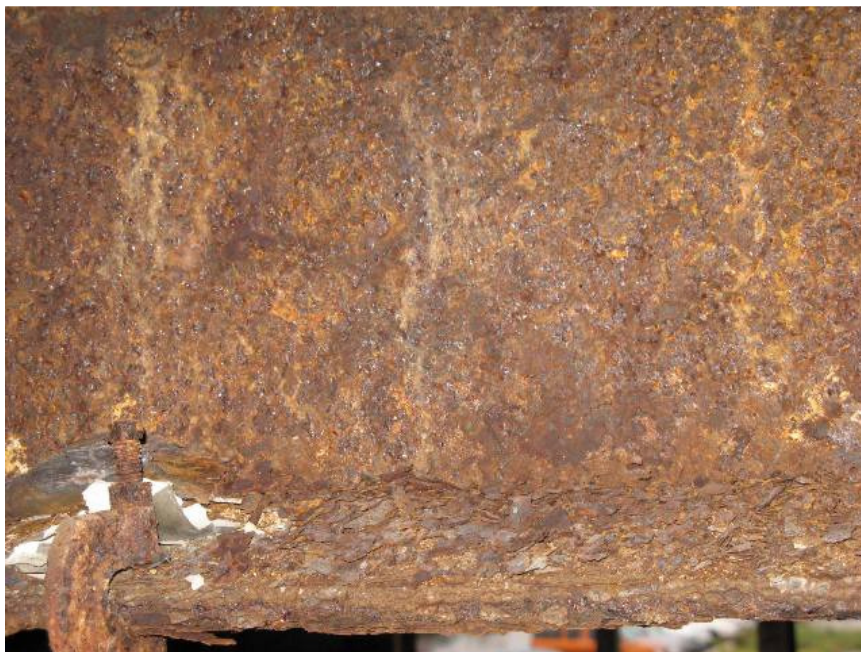
Photo #29: Heavily corroded bottom flange of steel girder below mezzanine slab

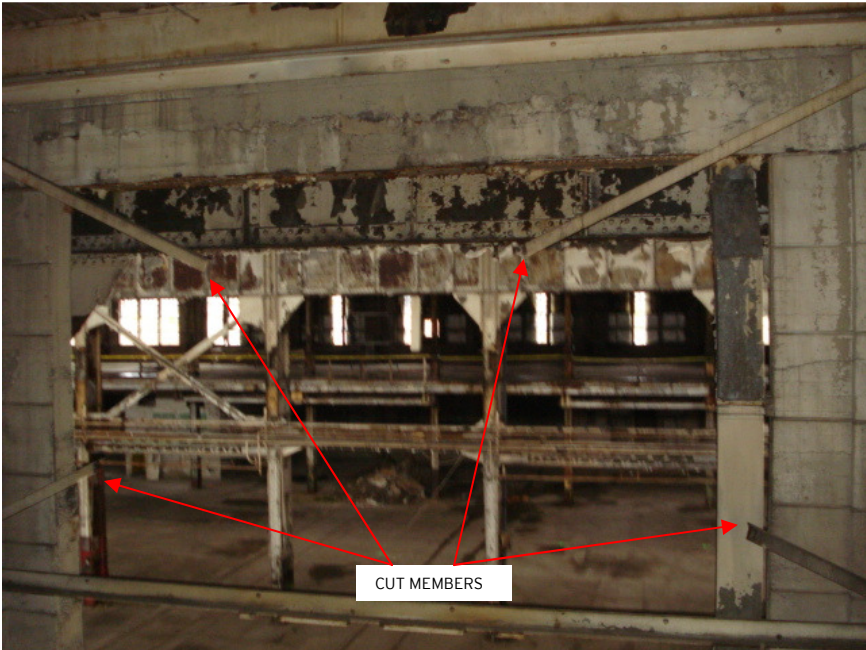
Photo #31: Vertical cross-bracing cut-out in addition

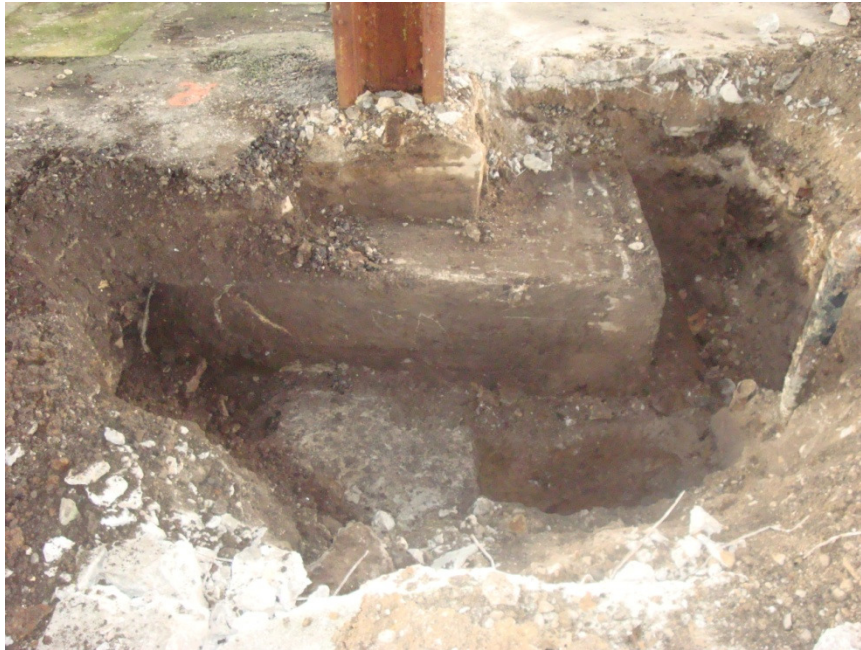
Photo #34: Test Pit #1 - Footing / Caisson Cap

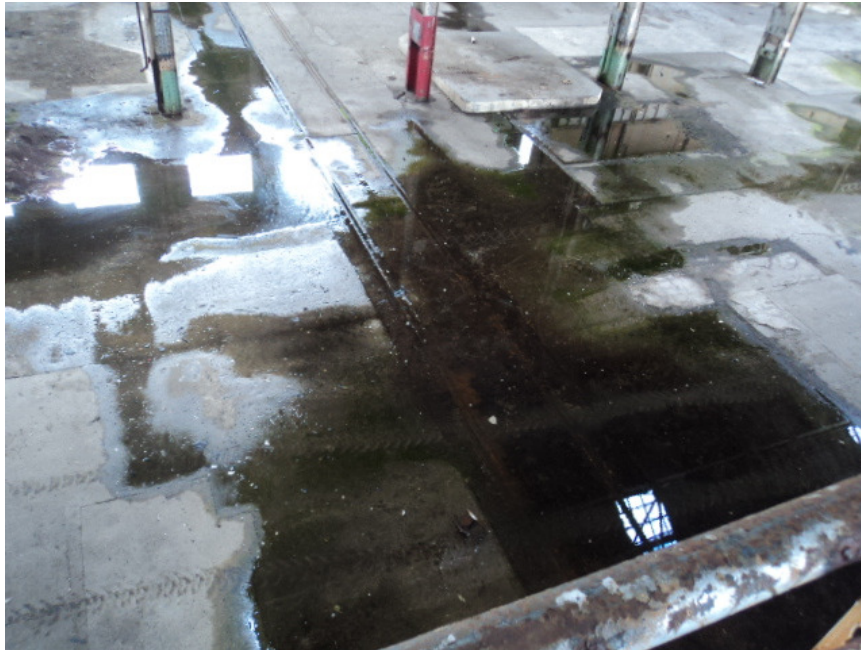
Photo #44: Slab-on-grade area of differential settlement

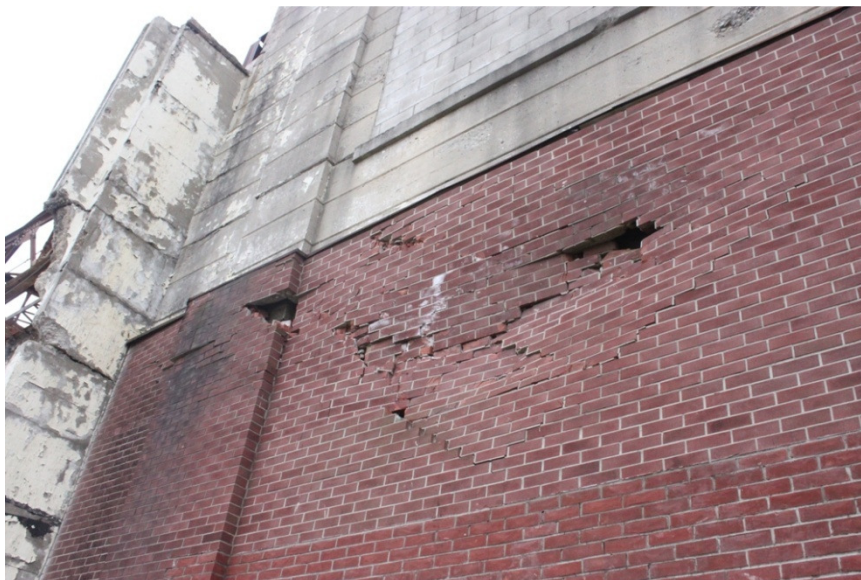
Photo #45: Impact damage and deterioration of exterior brick veneer

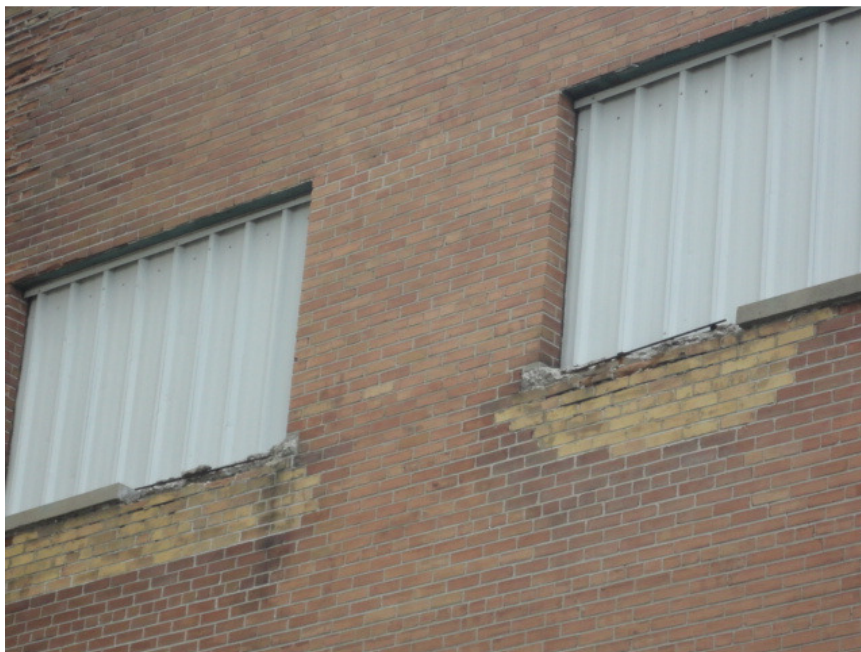
Photo #47: Typical repaired masonry below window sills

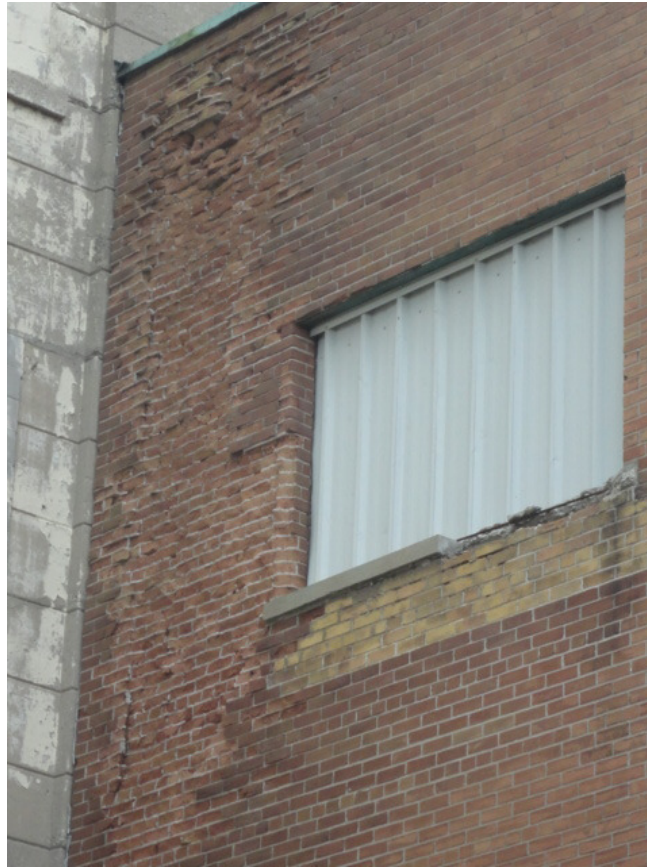
Photo #48: Deterioration of masonry wall at junction with existing wall

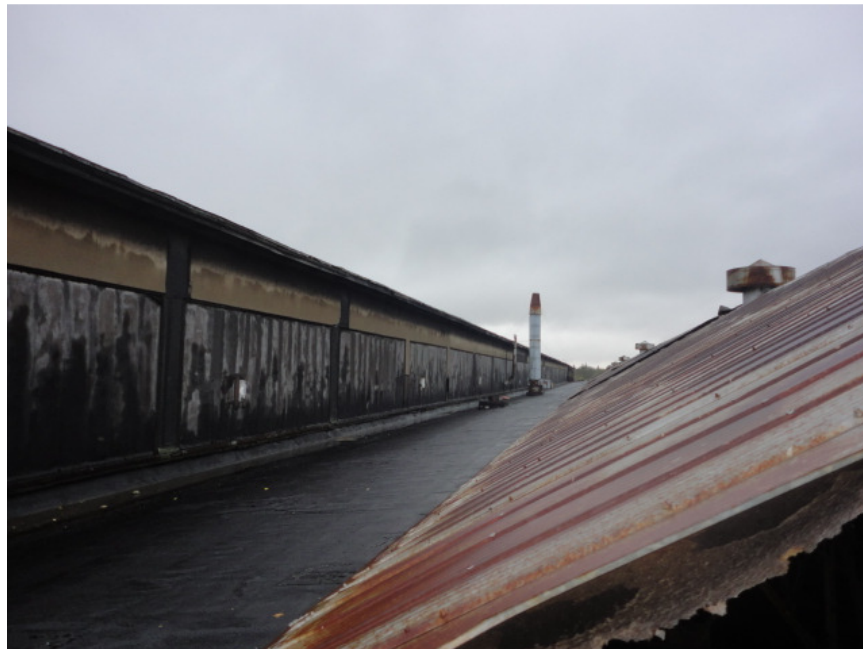
Photo #49: Typical roof assembly and condition
